Scissor Lift Failed to Meet Design Requirements

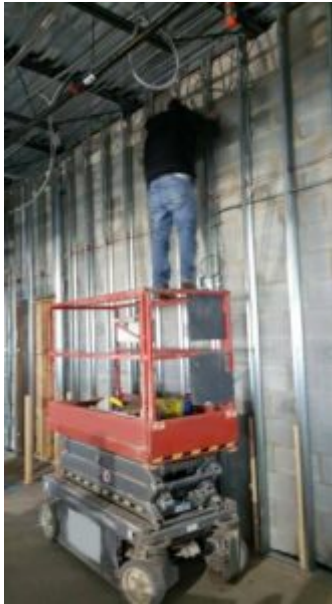
A worker was fastening hangers to the underside of roof trusses in a greenhouse using a hydraulic scissor lift. He fell from a height of about 11 feet and suffered serious injuries. The MOL investigation found that the worker was moving the scissor lift while it was fully extended, causing it to tip over. But instructions for the scissor lift specified that it shouldn't be operated while extended. The lift also hadn't been designed by a professional engineer to meet the requirements of the National Standards of Canada for self-propelled elevating work platforms. For example, it was missing anchorage points for securing safety belts and an emergency stop device or controls at ground level, among other things. His employer pleaded guilty to failing to ensure that a hydraulic scissor lift met the design requirements and was fined \$65,000 [*South Essex Fabricating Inc.*, Govt. News Release, March 24, 2014].
