Spot The Safety Violation: Worksite No Place for Balance Beam

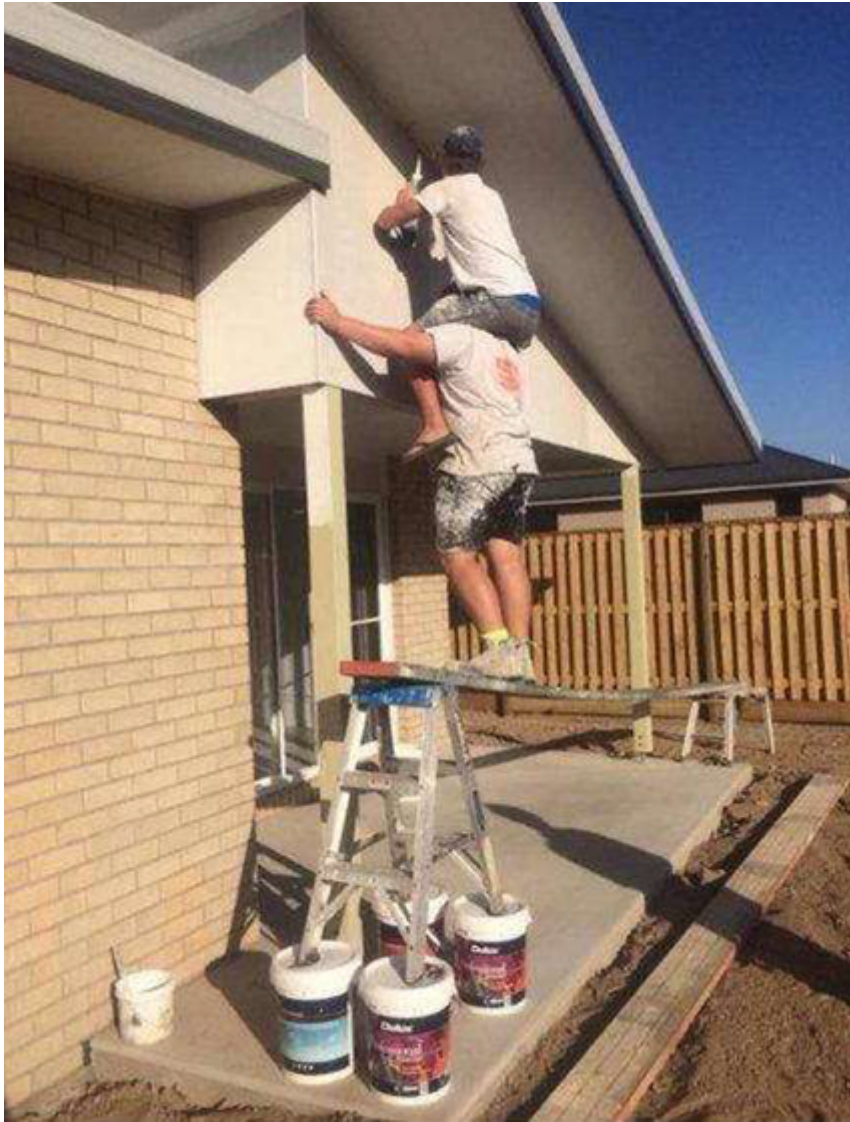
This picture from WorkSafe Victoria in Australia depicts several safety hazards.

First, there's simply no situation in which it's safe or appropriate for one worker to be sitting on the shoulders of a co-worker. Whether these painters are horsing around or honestly believe this technique is perfectly acceptable, their employer needs to put a stop to it immediately.

Second, the board the painters are standing on probably isn't wide enough and certainly is too long to not have some support. Just look at how it's sagging in the middle. In addition, they shouldn't be using a stepladder to support this horizontal walkway. And it doesn't appear that either of the board's ends are braced or secured. They could easily slip off their supports, causing the painters to fall.

Speaking of falls, although it's unclear exactly how high up the painters are, it looks like at least the one on top should be wearing appropriate fall protection.

Yes, the painters are working outside in sunny conditions. But a worksite isn't

a beach. So instead of wearing flip flops, the painter on top should be wearing appropriate footwear, such as boots. (Use this checklist to assess whether hazards exist in the workplace that could endanger workers' feet and, if so, whether those workers are adequately protected from the identified hazards by their footwear.)

Lastly, the stepladder is unsafely balanced on top of four buckets. Instead, the painters should be using a stepladder (or extension ladder) that's tall enough to give them safe access to the areas they need to reach. And they should ensure that the ladder is placed on flat, even ground.
