## Spot The Safety Violation: Worksite No Place for Balance Beam

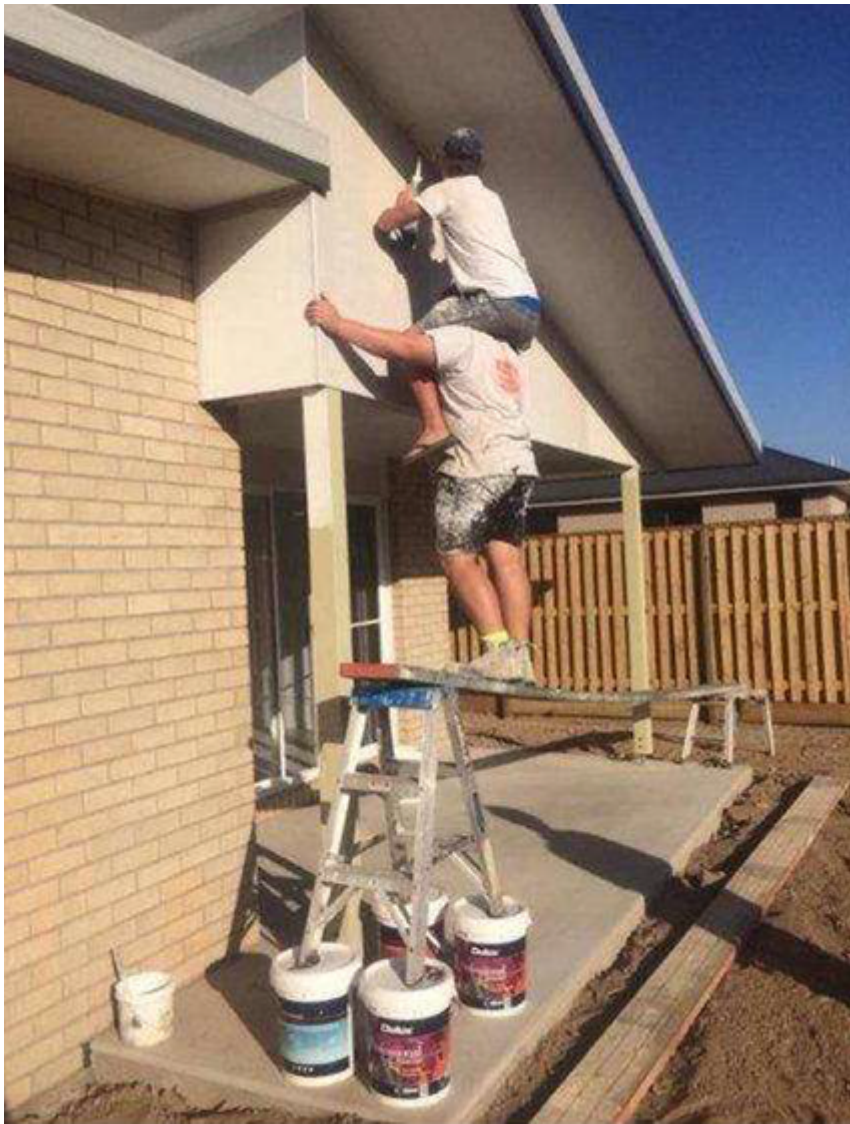
This picture from WorkSafe Victoria in Australia depicts several safety hazards.

First, there's simply no situation in which it's safe or appropriate for one worker to be sitting on the shoulders of a co-worker. Whether these painters are horsing around or honestly believe this technique is perfectly acceptable, their employer needs to put a stop to it immediately.

Second, the board the painters are standing on probably isn't wide enough—and certainly is too long to not have some support. Just look at how it's sagging in the middle. In addition, they shouldn't be using a stepladder to support this horizontal walkway. And it doesn't appear that either of the board's ends are braced or secured. They could easily slip off their supports, causing the painters to fall.

Speaking of falls, although it's unclear exactly how high up the painters are, it looks like at least the one on top should be wearing appropriate fall protection.

Yes, the painters are working outside in sunny conditions. But a worksite isn't

a beach. So instead of wearing flip flops, the painter on top should be wearing appropriate footwear, such as boots. (Use this checklist to assess whether hazards exist in the workplace that could endanger workers' feet and, if so, whether those workers are adequately protected from the identified hazards by their footwear.)

Lastly, the stepladder is unsafely balanced on top of four buckets. Instead, the painters should be using a stepladder (or extension ladder) that's tall enough to give them safe access to the areas they need to reach. And they should ensure that the ladder is placed on flat, even ground.
